Sight Distance at Murillo and Klein Is Too Short

Short Sight Distance at Murillo and Klein: Blind Curve

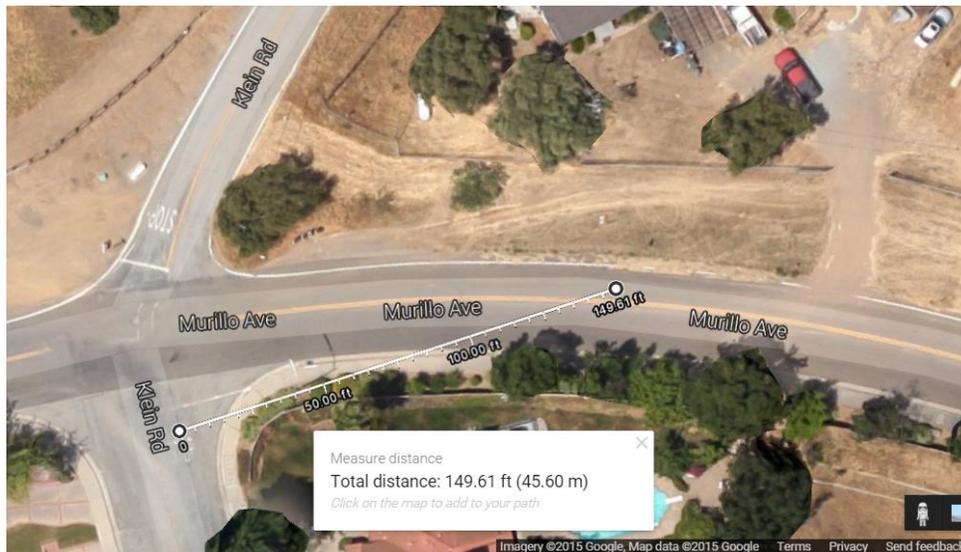
Two aspects of the uncontrolled intersection at Murillo Ave and Klein Rd make it particularly hazardous.

1. the blind curve just to the east
2. the steep climb of vehicles traveling toward the intersection and going southbound. The steep climb makes it difficult for those drivers to control their speed as they approach the intersection.

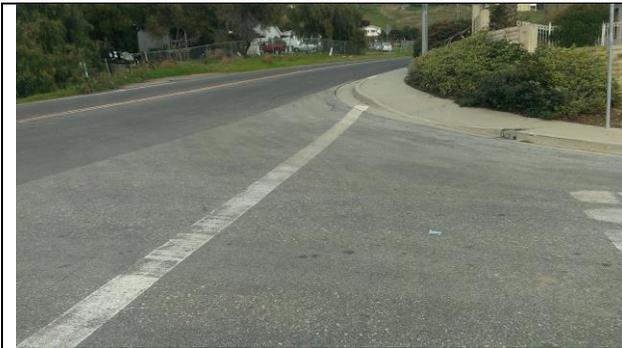
We found by direct measurements that the sight distance eastward is only **149 feet**, well short of the minimum required 200 feet. As did the consultant, we use Caltrans standards from the Highway Design Manual:

- Driver height: 3.5 feet
- Approach object height: 4.25 feet
- Driver setback: 15 feet. (The Caltrans standard is as follows: "Set back for the driver of the vehicle on the crossroad shall be a minimum of 10 feet plus the shoulder width of the major road but not less than 15 feet.")

Northbound on Klein Rd, looking to the east.
Visibility of 149 feet.

Even if the sidewalk landscaping were all cut, visibility would improve by only about 25 feet. The six-foot sound wall still makes for a blind curve.

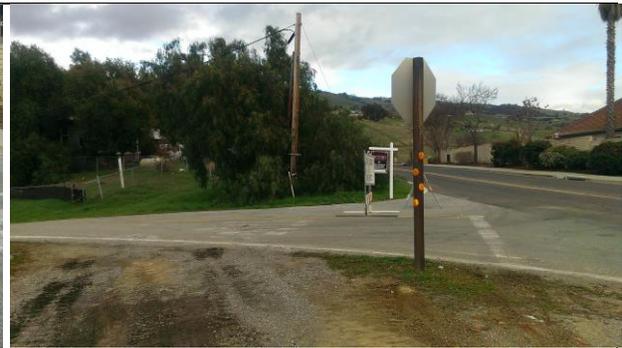
Southbound on Klein Rd, looking to the east. The sight distance here is even less.
